Silicon Precipitate Nodule-Induced Failures of MOSFETs

M. Johnson and D. Pote
Motorola, Inc.
Northbrook, IL

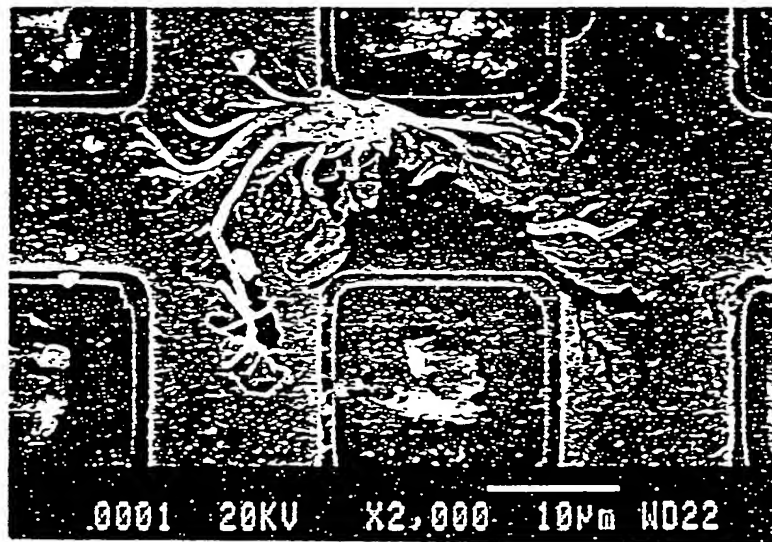
Figure 1: Unique pattern of fused polysilicon observed after removal of metallization and insulating oxide. (2000X)

Subsequent optical inspection identified an apparent electrical damage site under the wirebond. This damage was characterized by a central fused-site surrounded by multiple filaments (Figure 1). These filaments were dubbed "tentacles" or "roadkill" damage because of their appearance. SEM inspection of the same locations revealed surprisingly little

It is now believed that the filaments are the result of amplification of the damage at the original failure sites by the application of excess power during liquid crystal testing. A slightly higher level of power was necessary to counteract the obstructing heatsink effect of the relatively large wirebond. The heat generated at the damage site would initiate crystallization of the amorphous polysilicon depend-

ing on the amount of power dissipated. If the applied power during LC testing was maintained at 25 mW or less, little or no filament growth would occur. Deliberate "decoration" of the damage site by generating filamentation was a useful albeit destructive technique to simply confirm the presence of this failure mechanism since it requires only a readily available medium power optical microscope to locate the damage site.

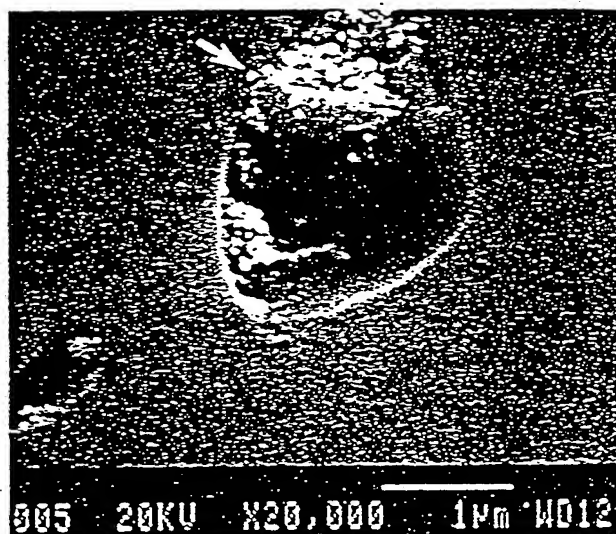
Figure 2: Small electrical damage site within chip.
(25000X)

Cross-sections of failures revealed that the filaments were confined to the polysilicon layer, except at the central nucleus. At the nucleus, melted silicon and aluminum were observed extending vertically through the dielectric layer. On several devices where the filamentation was minimal, there was limited evidence of melting at the nucleus site and a small section or chip of the dielectric was missing (figure 2).

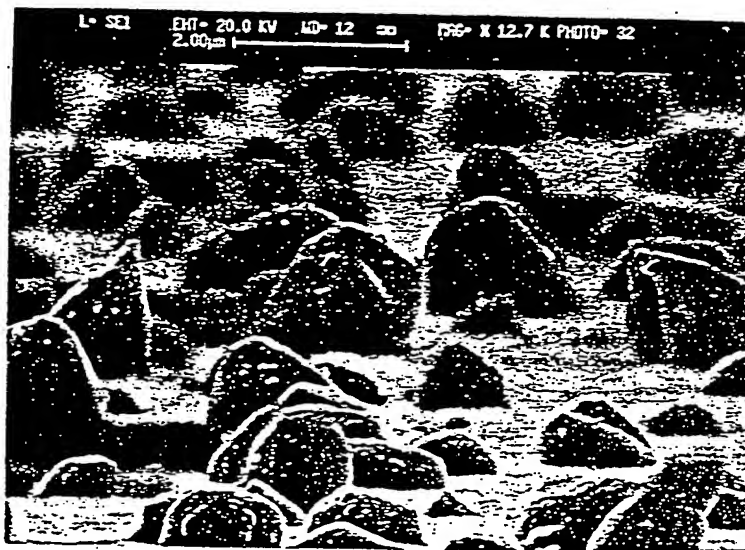
Figure 3: Silicon precipitates (nodules) viewed from side exhibit variety of shapes and sizes. (12700X)

shape. Although they appear roughly circular under high power microscopy (400X), they are actually polyhedral and exhibit a wide range of aspect ratios (Figure 3). Typical height/width ratios range from 0.3 to 1.8.

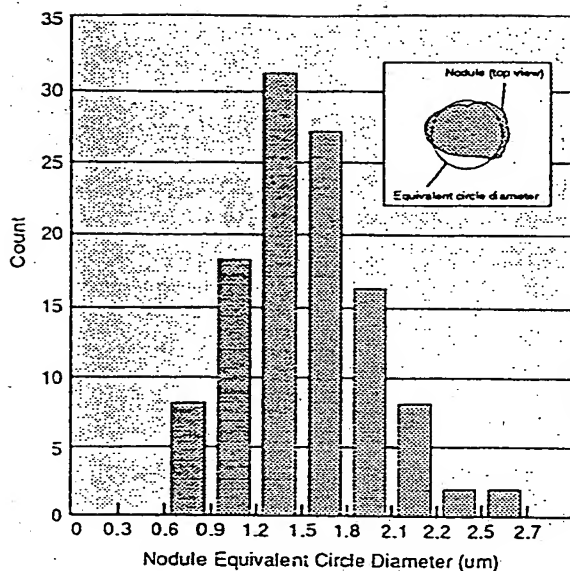
There were typically 50×10^3 to 100×10^3 nodules per square millimeter in the subject devices. In general, the nodule density -- the number of nodules per unit surface area -- was inversely proportionate to the average size of the nodules. That is, when the nodules were large, there tended to be few of them. Conversely, when the nodule count was high, they tended to be small. Figure 4 shows a typical histogram of nodule sizes produced by an image analysis

Figure 4: Example distribution of nodule sizes

system capable of performing feature counting. Unfortunately, easily measured characteristics of the nodules, such as density (count/area), could not be easily correlated to failure rate. It is hypothesized that the probability of failure is governed by extreme value statistics (weakest link theory), and detailed info regarding the shape and size of the nodules can be difficult to obtain on a large number of samples.

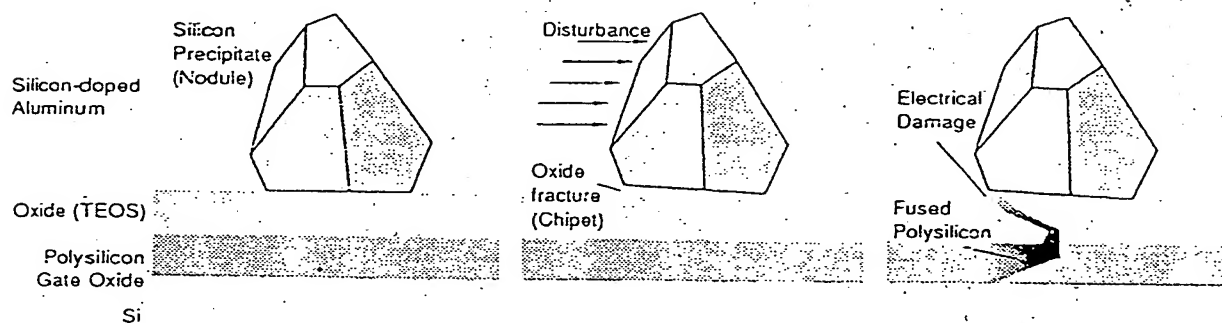
The adhered nodules could be removed quite easily; gentle brushing of a few fibers from a cotton swab was sufficient to disturb them. When these well-adhered nodules are displaced, they often take with them a portion of underlying oxide, forming a distinctive, football-shaped chip-out, or *chipet* (Figure 5). The depth of the resulting chipet was roughly equal to half the length of the chipet's minor axis, itself related to the area of contact between nodule and oxide.

In the MOSFET devices the lateral displacement of the nodules occurs during the wirebonding process. The cavity formed by the chipet is immediately filled with aluminum. These chipets, during

Figure 5: Movement of nodule results in fracture of underlying oxide.

electrical stress, appear to act as weak points in the insulating oxide. If the chipet is sufficiently deep to fully compromise the thickness of the dielectric oxide, a linear resistive short between the source metallization and gate polysilicon results. However, if the root only partially compromises the dielectric, a leaky diode-like characteristic results.
